600,000 Gallon Mountain Road Storage Tank Condition Assessment Report

Village of Irvington, NY

Date
October 19, 2009

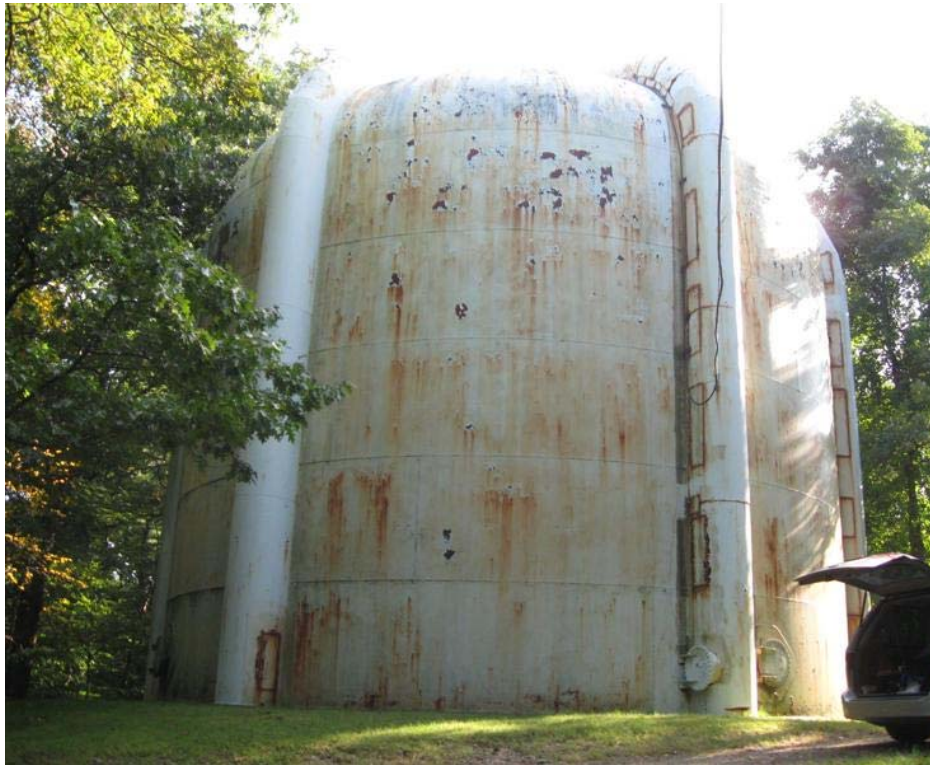
The exterior coating system is in very poor condition. The exterior coating system is exhibiting areas of corrosion, mildew, chalking, and delamination of the finish coat. The appearance of the coating system is poor with areas of mildew, chalking and oxidation. There are localized areas of heavy rust on the decorative pilasters, sidewalls and roof of the tank.

The dry film thickness on the exterior shell is between 5.8 and 11.7 mils. The adhesion of the exterior coatings is poor and not suitable for overcoating. There is evidence of lead based paint or primer under the urethane coating. (See photos # 1 - 4).

Photo #1 Mildew staining, corrosion, chalking, and coating failure on sidewalls.

- **Within the next year, the exterior coating system should be properly prepared by sandblasting to a SSPC #6 Standard and coated with a 3 coat urethane system to prevent permanent damage to the tank and any further loss of metal.**
- **Additionally, the decorative pilasters should be removed due to the severe corrosion in several areas. Relocation of the inlet pipe may be necessary once the pilasters are removed.**
- **Due to the age and poor condition of the tank it is recommended that the Village evaluate the cost of repairing the tank against the cost of constructing a new tank on this site.**
